Conservation Restriction Monitoring Report

Fall 2013

Prepared for
The Newton Conservators
By Liz Newlands
Mass Audubon Ecological Extension Service

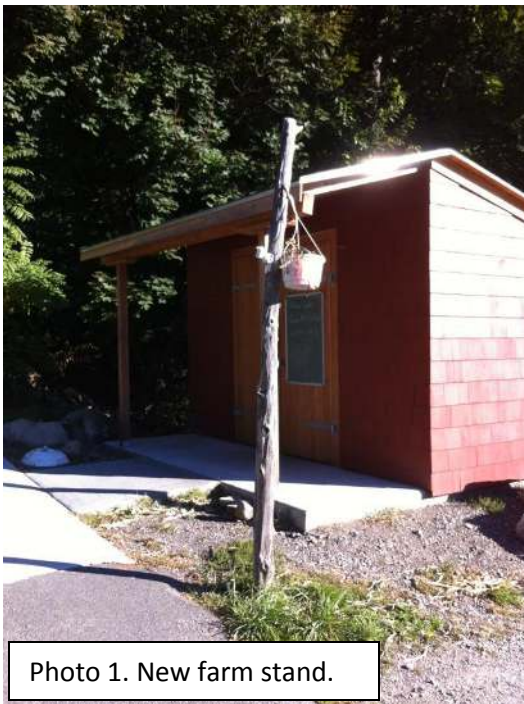
Remains of the burned vegetable stand were removed and a new, handicapped accessible stand constructed in its place (Photos 1 & 2). A chicken coop and small poultry yard were added to the property, though eggs are primarily consumed by the resident farmer and his family (Photo 3). A cold storage locker has been added to the property to improve processing vegetables for consumption. A port-a-potty has also been added for convenience (Photo 4). The barn was also undergoing extensive renovations, and all work was being performed on the existing structure (Photo 5). Lastly, a row of thriving fruit trees, planted along the western boundary in honor of former Conservator Carol Lee Corbett (Photo 6).

Photo 1. New farm stand.

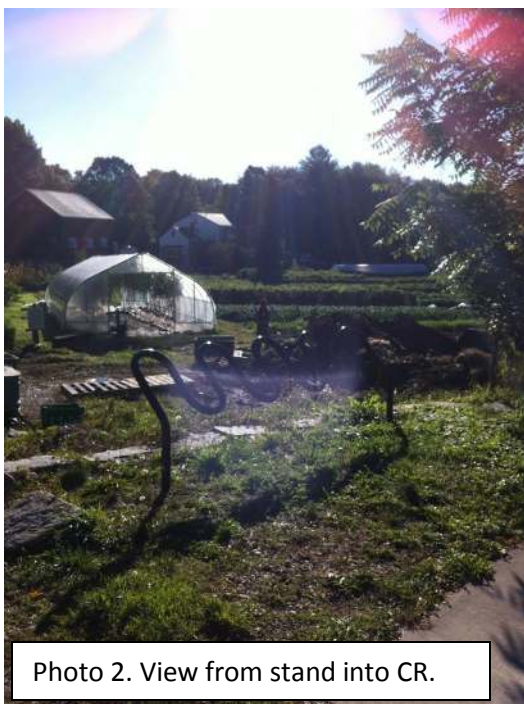
Photo 2. View from stand into CR.

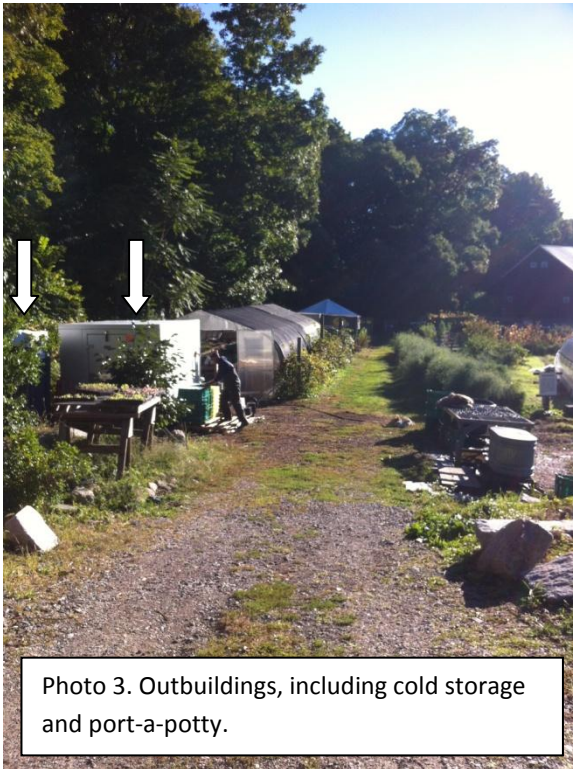
Photo 3. Outbuildings, including cold storage and port-a-potty.

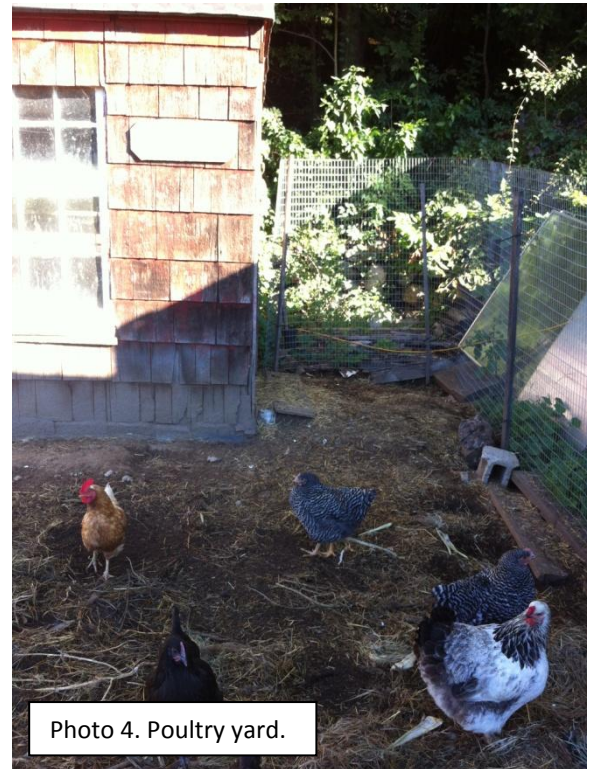
Photo 4. Poultry yard.

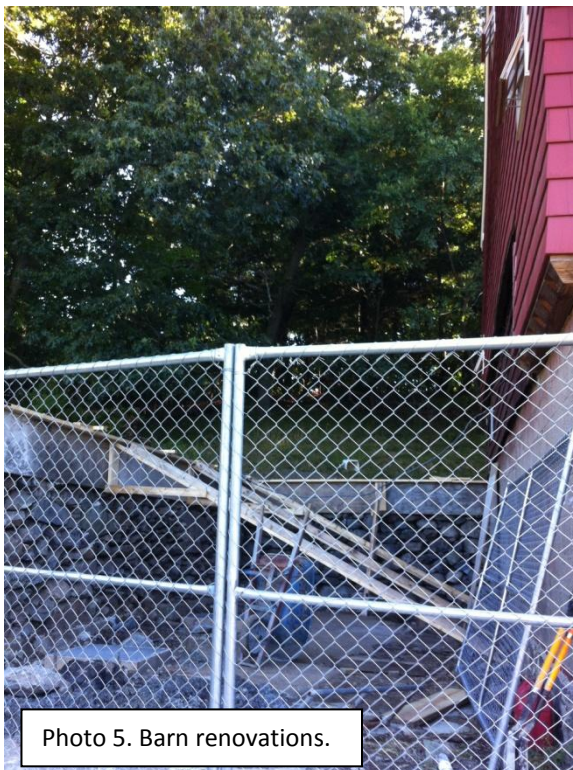
Photo 5. Barn renovations.

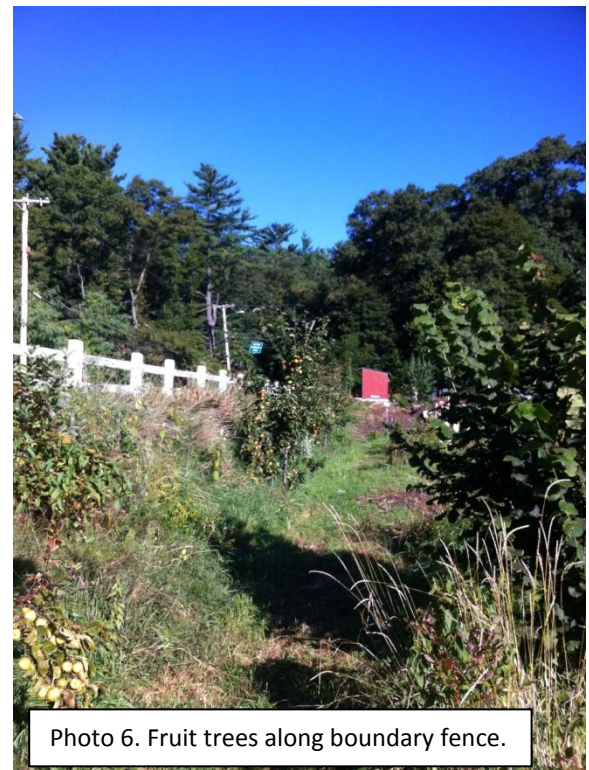
Photo 6. Fruit trees along boundary fence.

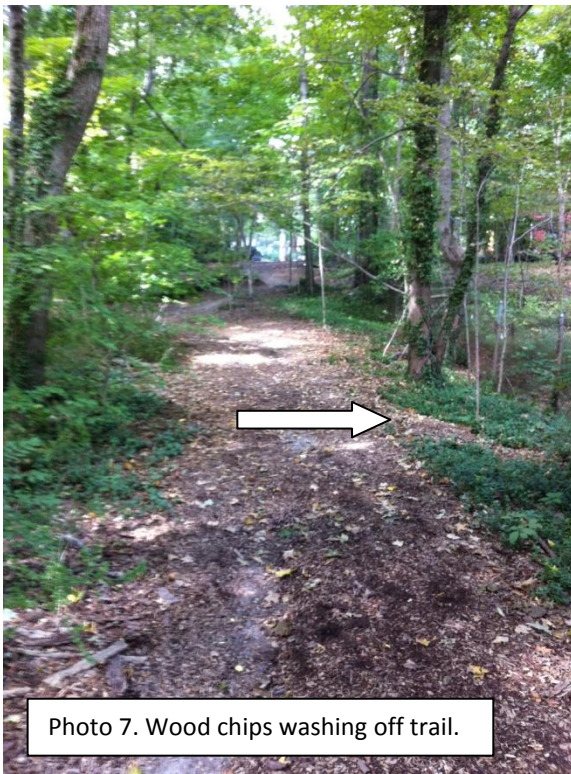
The Wilmerding property abuts the Chestnut Hill Reservation which lies to the east. One access to the reservation and the Wilmerding property is off of Elgin Road. A small intermittent stream, Thomasville Brook, flows through the Wilmerding CR. It passes underneath the trail a short distance from the entrance, and flows to the northeast contributing to the Hammond Pond catchment area. Wood chips recently placed on the trail have washed into the stream bed, and appears to occasionally clog the small culvert/pipe through which the stream flows under (Photos 7 & 8). The wood chips pose a potential erosion problem as water may get backed up into the stream bed, which could flood the Wilmerding CR and the trail. We suggest the Conservators work with the Newton Conservation Commission to address trail maintenance at this location. It may be possible to plant some wetland tolerant shrubs to help slow the flow of water from the trail into the stream bed, curtailing erosion and flooding problems.

Photo 7. Wood chips washing off trail.

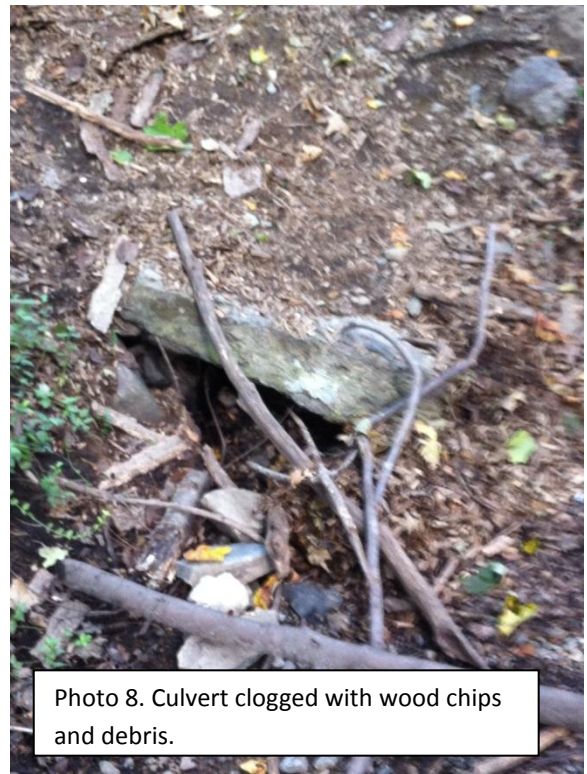
Photo 8. Culvert clogged with wood chips and debris.

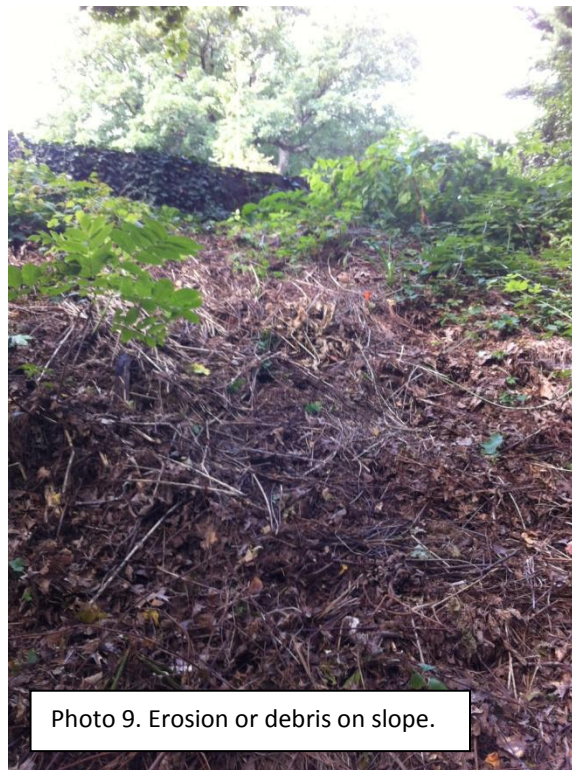
A small area along the steep, western boundary was denuded of the ground ivy that carpets most of the property (Photo 9). It is possible that dumped organic debris was placed here and later washed away: it is difficult to tell. We recommend that future site visits include monitoring for dumped leaves, grasses and other yard waste, and that the conservators maintain open communication with abutters to discourage any dumping since it is prohibited in the terms and conditions of the C.R.

Photo 9. Erosion or debris on slope.

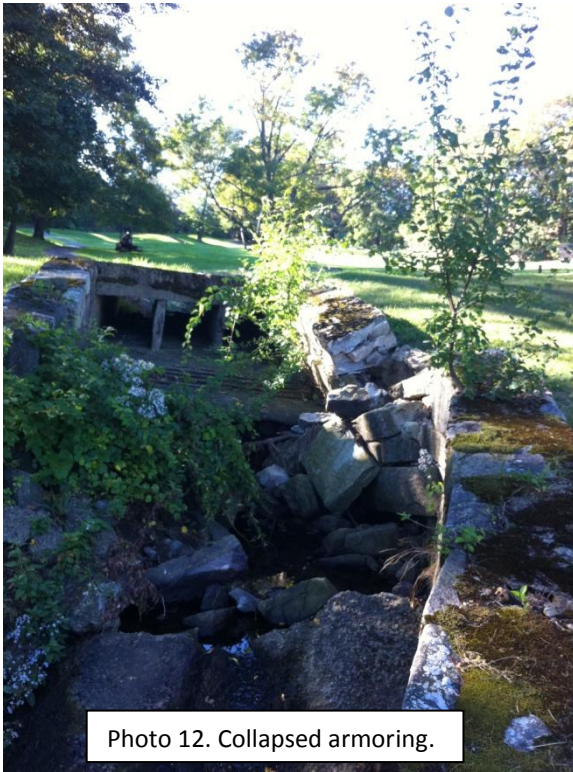
Overall the property was in good condition. Board members from the Newton Conservators helped to identify several conditions that will need to be monitored closely on subsequent visits. First and foremost, a stone and cement crossing structure over the armored drainage running through the property has partially collapsed (Photo 10 - 13). We spoke with golf course personnel at the end of our visit, and they were well aware of the structural failures at the crossing. We highly recommend that the conservators follow-up with staff from the golf course, and that the conservators also notify the Newton Conservation Commission who has jurisdiction over the drainage under the Wetlands Protection Act. The City of Newton will likely be responsible for the repairs to the structure, and we also suggest contacting city engineers or the Department of Public Works.

Photo 12. Collapsed armoring.

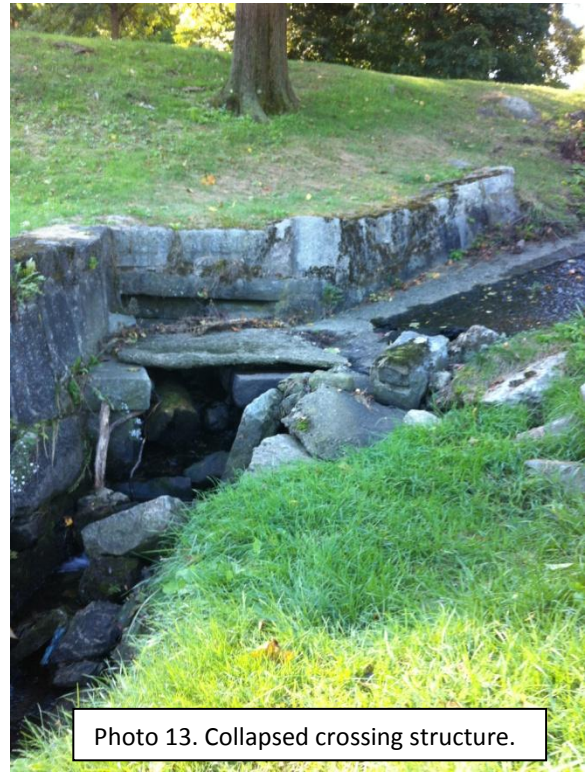
Photo 13. Collapsed crossing structure.

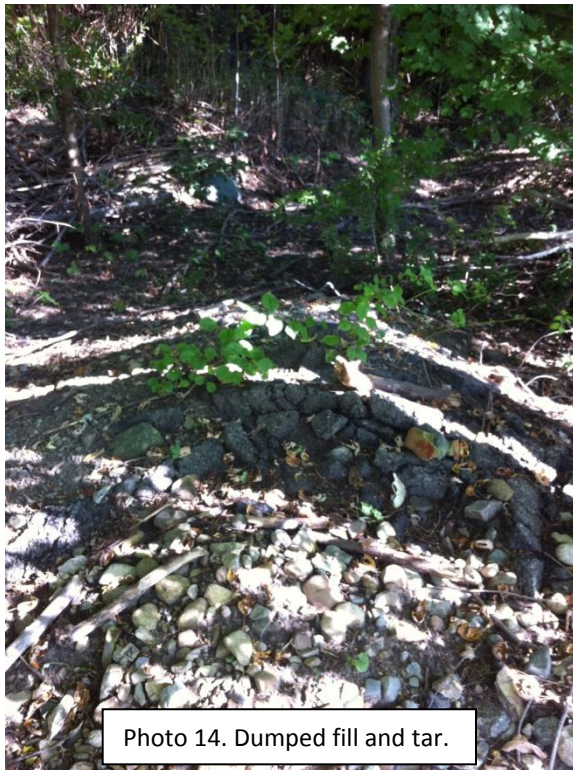
Small amounts of organic debris and dumped materials which look to be tar and rocks (possibly from pathway and bridge improvements) were found along the northern perimeter fence (Photo 14), and organic debris in the far southwest corner of the property (Photo 15). These activities are prohibited in the CR:

3(f) ...the dumping on the Property of soil, refuse, trash, vehicle bodies or parts, trailers, rubbish, debris, junk, waste, or other such substance, whether or not generated on the Property.

Photo 14. Dumped fill and tar.

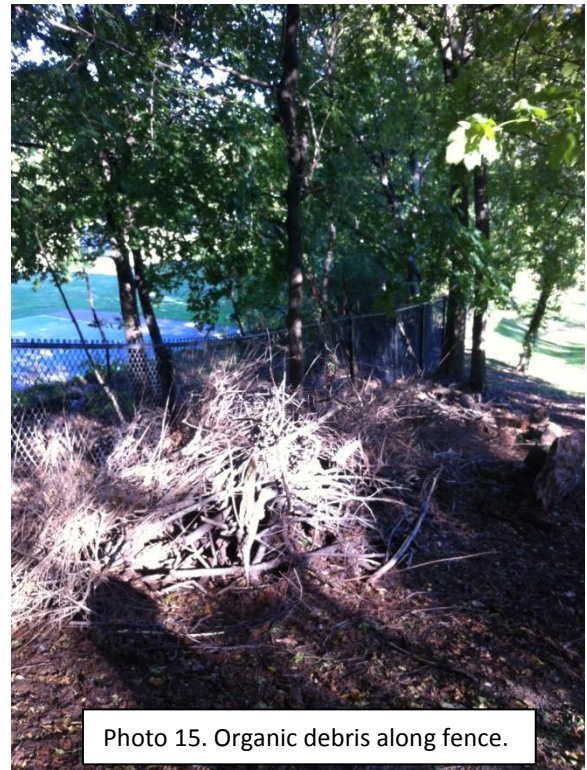
Photo 15. Organic debris along fence.

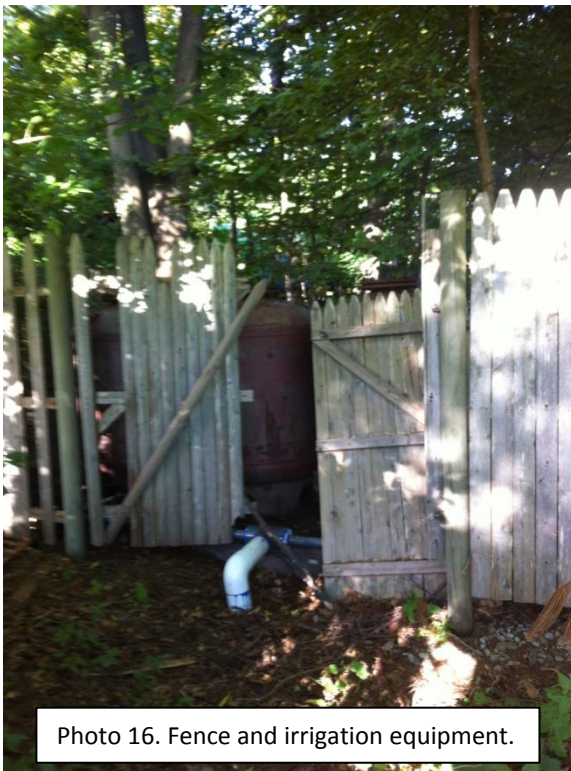
A stockade fence found under a canopy of pine trees on the steep hill across from the club house shelters a small shed, pipes and valves, as well as several holding tanks (Photo 16). This appears to be a pump-house and machinery used for irrigation of the property.

Photo 16. Fence and irrigation equipment.

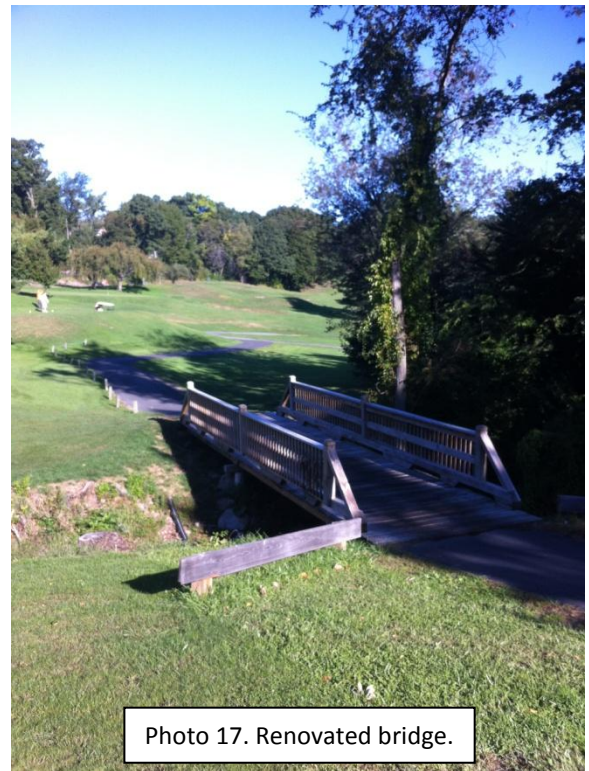
Finally, renovations to the bridge noted in the 2010 monitoring report are complete (Photo 20).

Photo 17. Renovated bridge.

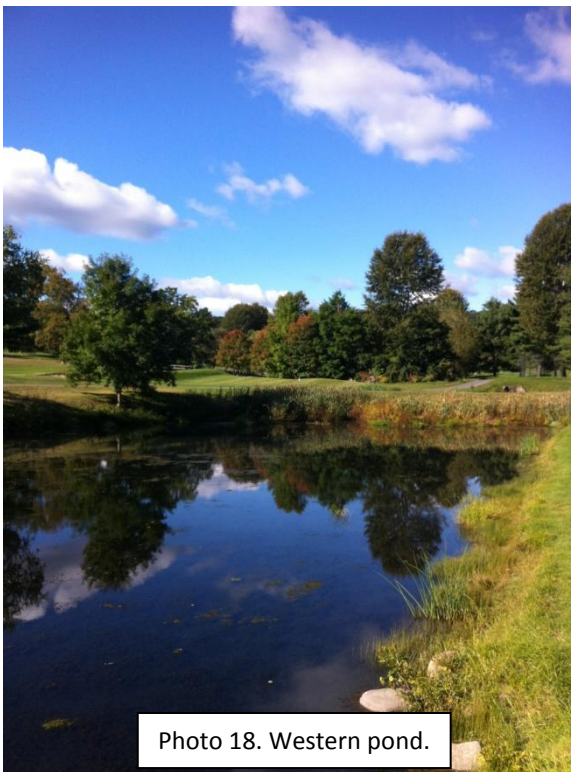
The two large ponds on the property appear to be in fair condition with clear water quality and no noticeable odor. The Newton Conservators raised concern about these pools in the past, and we have provided photos of them (Photo 17 & 18). In addition to the ponds, we noted cracks in the foundation of the retaining pond near the pump-house at the center of the property. It appears repairs have been made in the past. Soggy turf at the base of this wall indicates that it still leaks. A structural failure of this wall could be a threat to the aquatic resources on the property if a large amount of water and sediment enters the system during an extreme event. We suggest the Newton Conservators work with the golf course operators and the City of Newton, including the Newton Conservation Commission, to see that the wall is repaired.

Photo 18. Western pond.

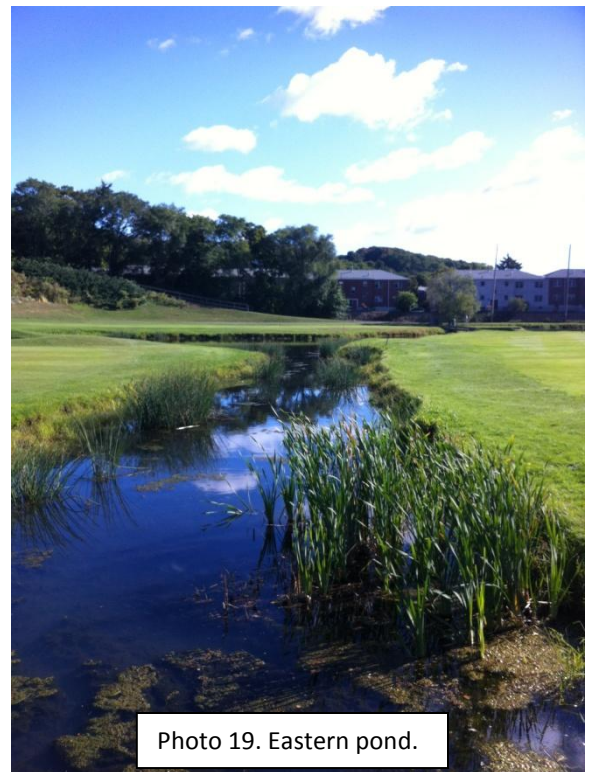
Photo 19. Eastern pond.

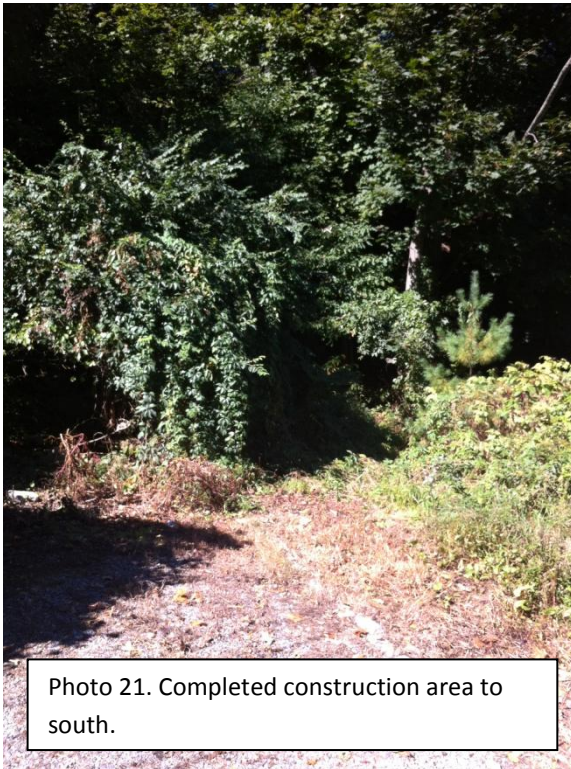
Conditions at Prospect Park have changed little since the last monitoring visit. Construction at an adjacent residential lot is complete (Photo 21). Norway Maple growth at this site is robust, as it is at other Newton Conservator properties (Photo 22 & 23). The infestation is significant enough that recommending an appropriate course of action to re-habilitate the property is challenging. Removal of the Norway Maple canopy may be the best start. These trees were initially planted as urban street trees for their capacity to provide ample shade. However, in a natural setting, shading from Norway Maples suppresses the growth of virtually all other species. Removing mature Norway Maples from the site will likely encourage the growth of native saplings, and begin the restoration process.

Photo 21. Completed construction area to south.

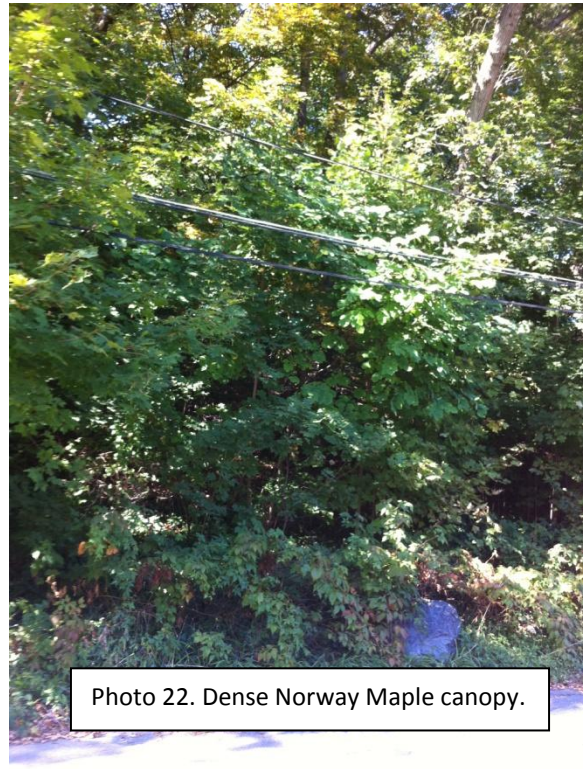
Photo 22. Dense Norway Maple canopy.

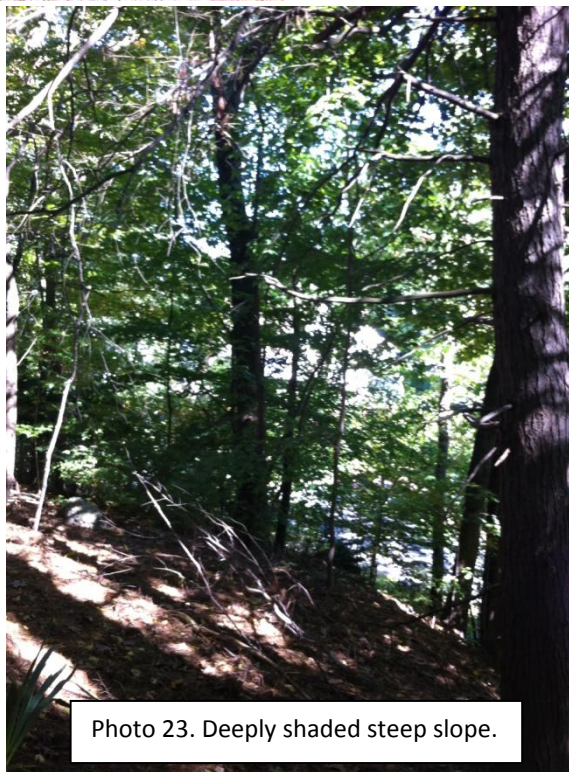
Photo 23. Deeply shaded steep slope.

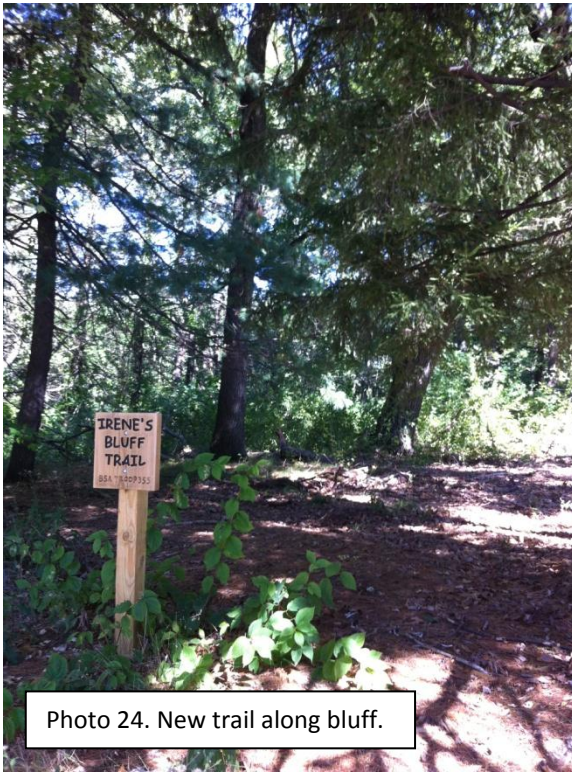
The Webster Park property now features a trail overlooking the Dolan Pond Conservation Area. This trail was constructed by a youth from a local scouting organization and winds along a bluff lined with evergreen trees ending at a bench. The construction of this trail was allowable under the terms and conditions of the CR, but may have been done without consultation with the Newton Conservators. As noted earlier, erecting proper signage at the properties will raise the visibility of the organization and help to ensure best management practices.

Photo 24. New trail along bluff.

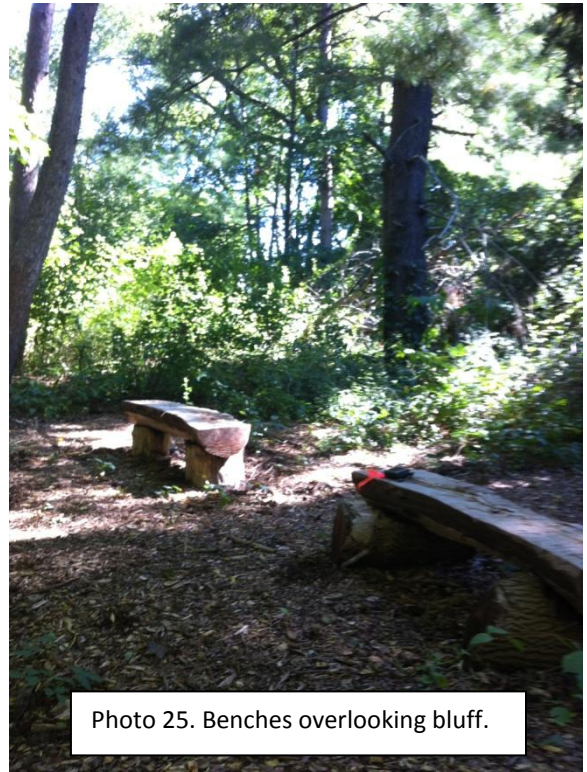
Photo 25. Benches overlooking bluff.

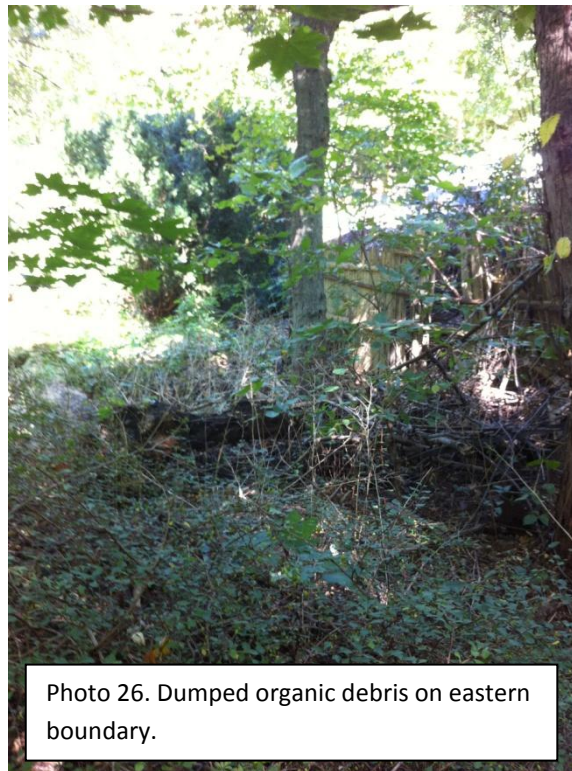
Photo 26. Dumped organic debris on eastern boundary.

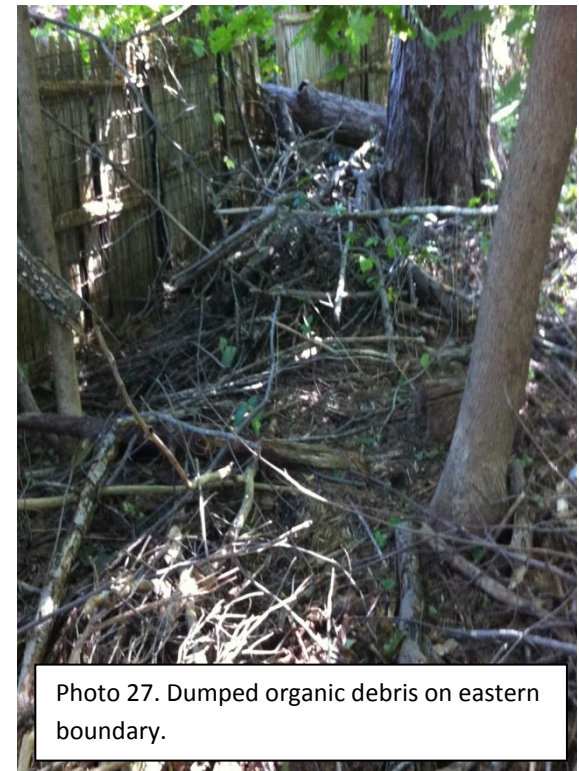
Photo 27. Dumped organic debris on eastern boundary.
