Conservation Restriction Monitoring Report

Fall 2013

Prepared for
The Newton Conservators
By Liz Newlands
Mass Audubon Ecological Extension Service

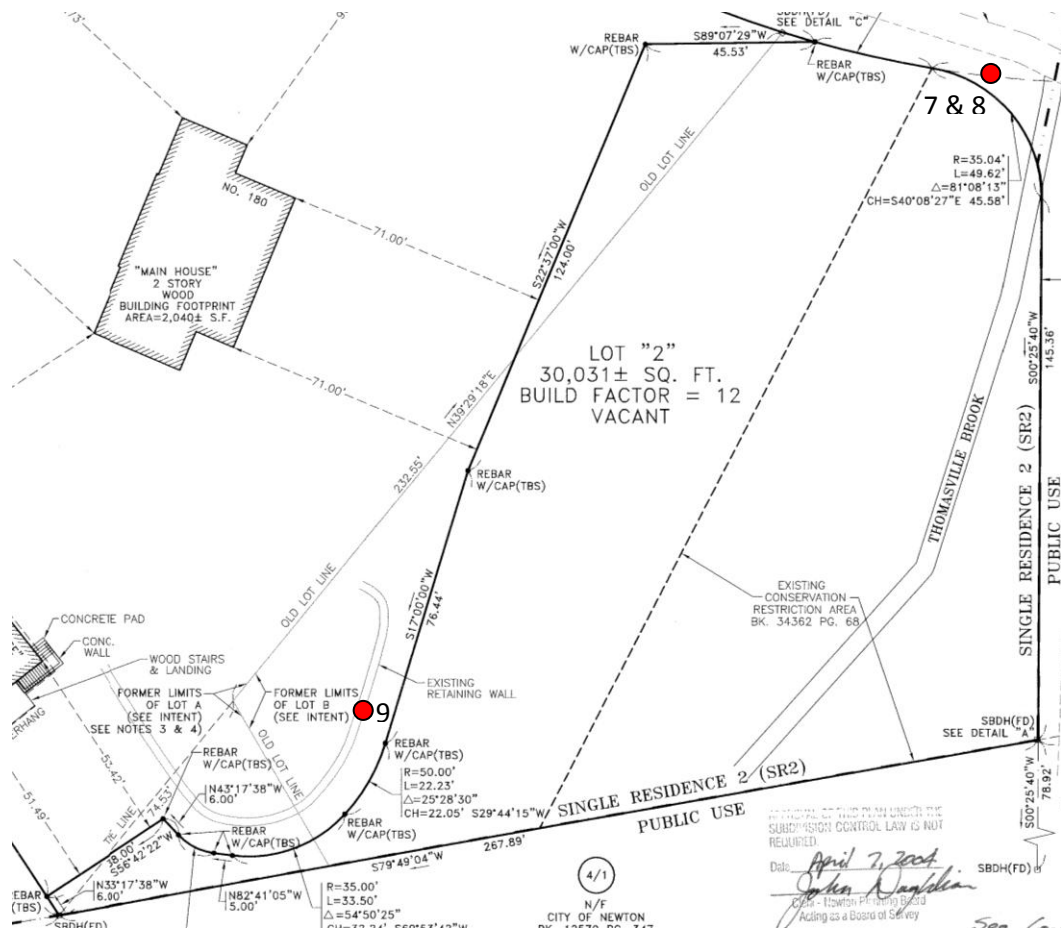
The Wilmerding property abuts the Chestnut Hill Reservation which lies to the east. One access to the reservation and the Wilmerding property is off of Elgin Road. A small intermittent stream, Thomasville Brook, flows through the Wilmerding CR. It passes underneath the trail a short distance from the entrance, and flows to the northeast contributing to the Hammond Pond catchment area. Wood chips recently placed on the trail have washed into the stream bed, and appears to occasionally clog the small culvert/pipe through which the stream flows under (Photos 7 & 8). The wood chips pose a potential erosion problem as water may get backed up into the stream bed, which could flood the Wilmerding CR and the trail. We suggest the Conservators work with the Newton Conservation Commission to address trail maintenance at this location. It may be possible to plant some wetland tolerant shrubs to help slow the flow of water from the trail into the stream bed, curtailing erosion and flooding problems.

A small area along the steep, western boundary was denuded of the ground ivy that carpets most of the property (Photo 9). It is possible that dumped organic debris was placed here and later washed away: it is difficult to tell. We recommend that future site visits include monitoring for dumped leaves, grasses and other yard waste, and that the conservators maintain open communication with abutters to discourage any dumping since it is prohibited in the terms and conditions of the C.R.

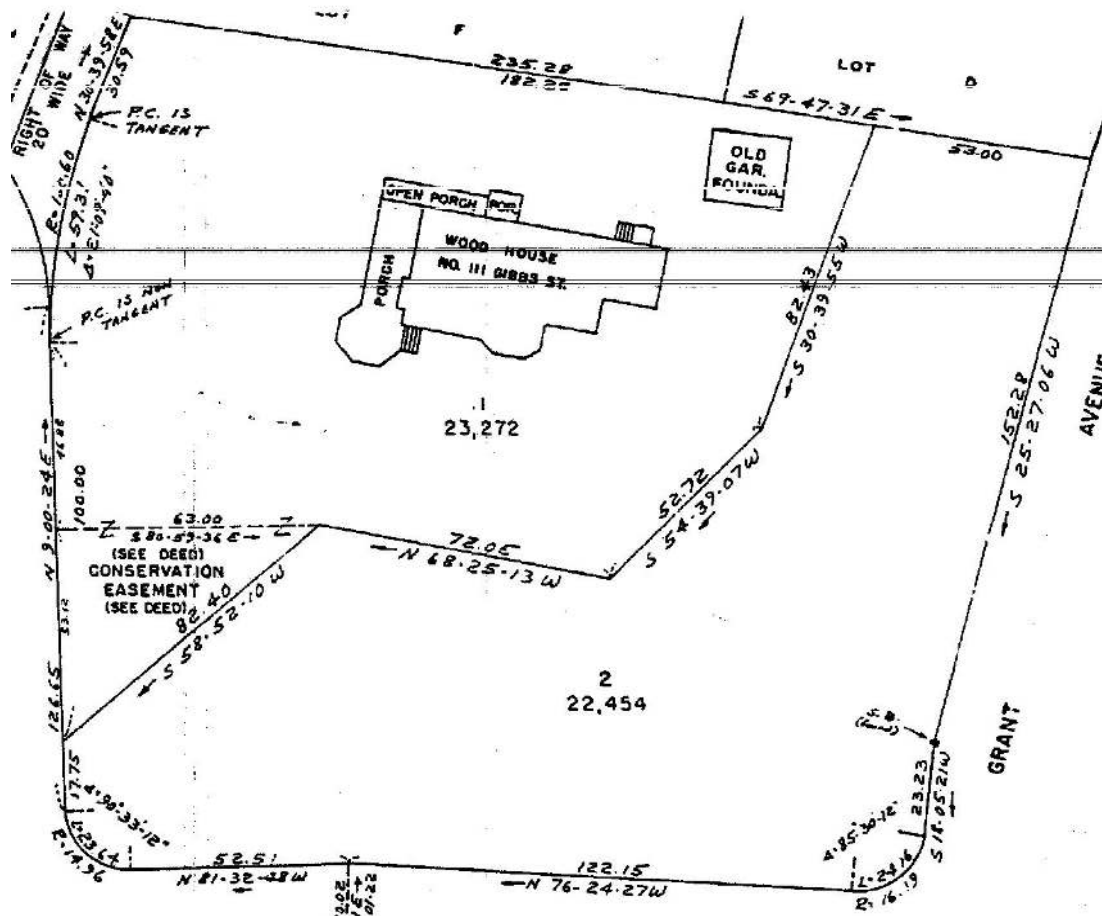
The Ordway property was again found in good condition. Wind-blown trash present during the last monitoring visit was absent, though it is likely problematic from time to time. Downed limbs from winter storms have not been removed from the property shown in diagram did not register in camera). It is possible that the limbs may be chipped on-site and placed on trails, a practice which is consistent with the terms and conditions of the CR.

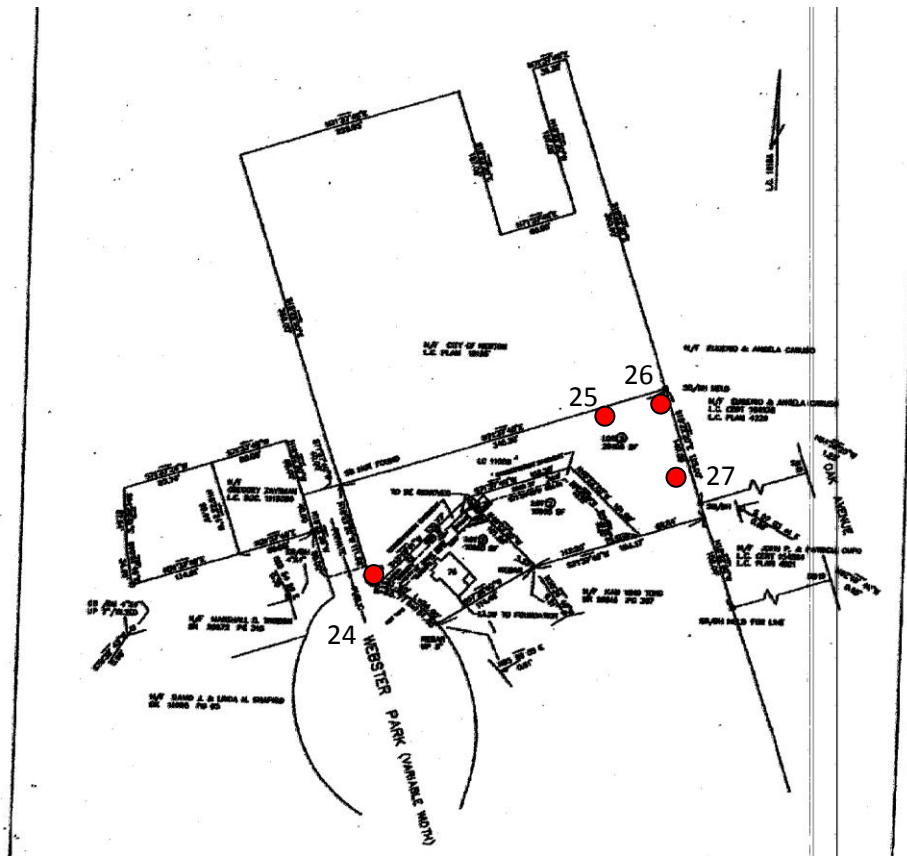
The Webster Park property now features a trail overlooking the Dolan Pond Conservation Area. This trail was constructed by a youth from a local scouting organization and winds along a bluff lined with evergreen trees ending at a bench. The construction of this trail was allowable under the terms and conditions of the CR, but may have been done without consultation with the Newton Conservators. As noted earlier, erecting proper signage at the properties will raise the visibility of the organization and help to ensure best management practices.

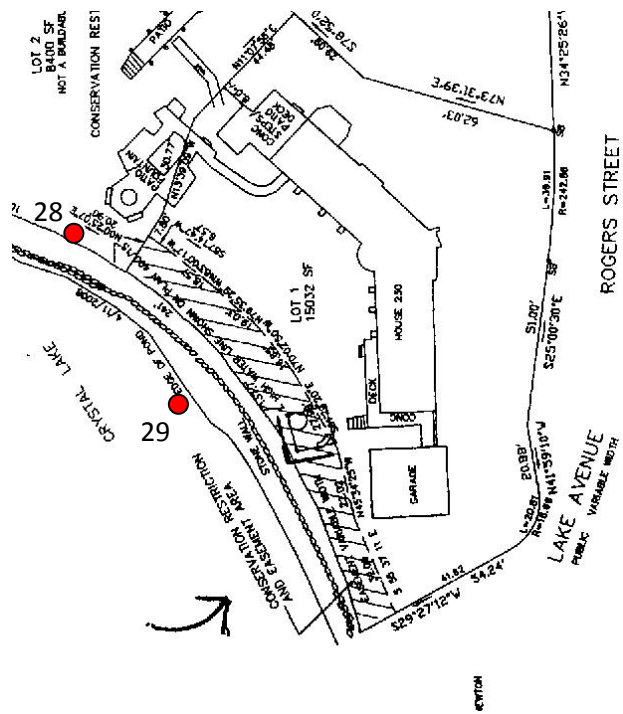
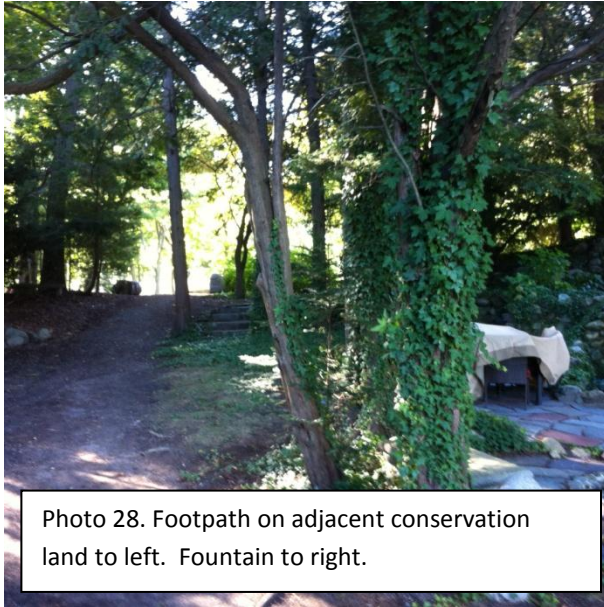
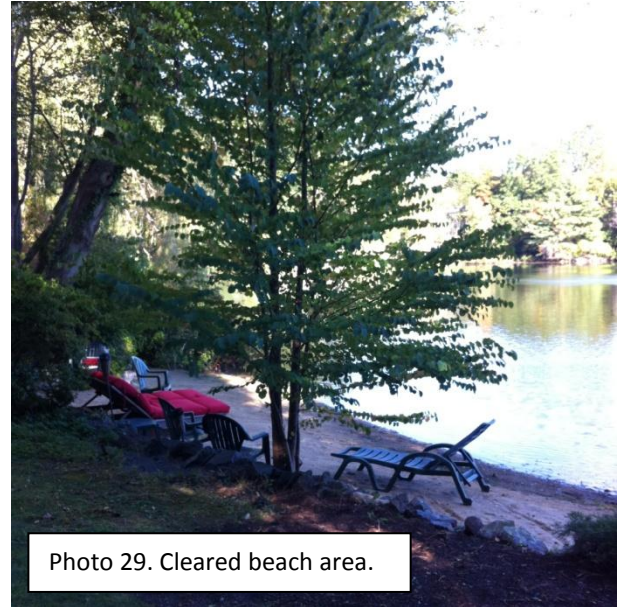
Boundaries of the Crystal Lake CR are still not marked in the field. An unusual configuration, delineating the pathway behind the residence and portions of the fountain and garden, are difficult to ascertain precisely, and therefore activity cannot be accurately monitored. We again recommend that the Conservators mark the boundaries of this CR, perhaps with discrete steel rods such as those used by surveyors.

It came to our attention that the residence abutting the CR property is occupied by new owners. The fountain near the end of the path (Photo 28) is subject to a separate CR (Fountain Easement recorded at Middlesex South Registry of Deeds Book 57781 Page 239) which states that the easement would be terminated upon conveyance of the property:

The remaining portion of the CR was in good condition, though clearing along the beach has increased (Photo 29).

Boundaries at this property are also unclear and unmarked in the vicinity of the gardens and water feature (Photo 29). Property protecting the property and ensuring the terms and conditions of the CR are upheld require a clear delineation of the boundaries. We suggest some discrete markings be placed at the boundaries of this property so that future monitors can conduct visits quickly, and that the property be.

We suggest the Newton Conservators retain legal counsel to investigate the sale of the property, and how this affects the Fountain Easement CR.
